## Uniform Mitigation Verification Inspection Form

| Inspection Date: <b>August 8, 2023</b> | | |
| Owner Name: <b>Mariners Village Condos</b> | | Contact Person: |
| Address: <b>2418 Coach House Blvd</b> | | Home Phone: |

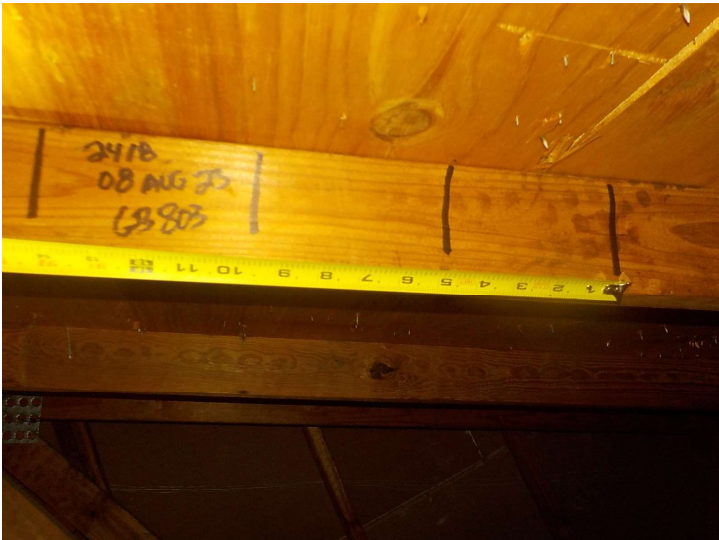
- ☒ C. Plywood/OSB roof sheathing with a minimum thickness of 7/16" inch attached to the roof truss/rafter (spaced a maximum of 24" inches o.c.) by 8d common nails spaced a maximum of 6" inches in the field. -OR- Dimensional lumber/Tongue & Groove decking with a minimum of 2 nails per board (or 1 nail per board if each board is equal to or less than 6 inches in width). -OR- Any system of screws, nails, adhesives, other deck fastening system or truss/rafter spacing that is shown to have an equivalent or greater resistance than 8d common nails spaced a maximum of 6 inches in the field or has a mean uplift resistance of at least 182 psf.

Roof Deck Fastener Spacing

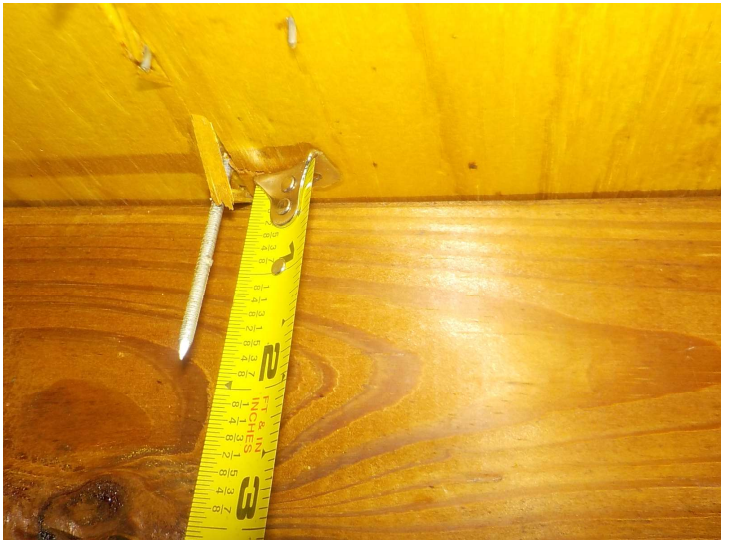
Roof Deck Fastener Size

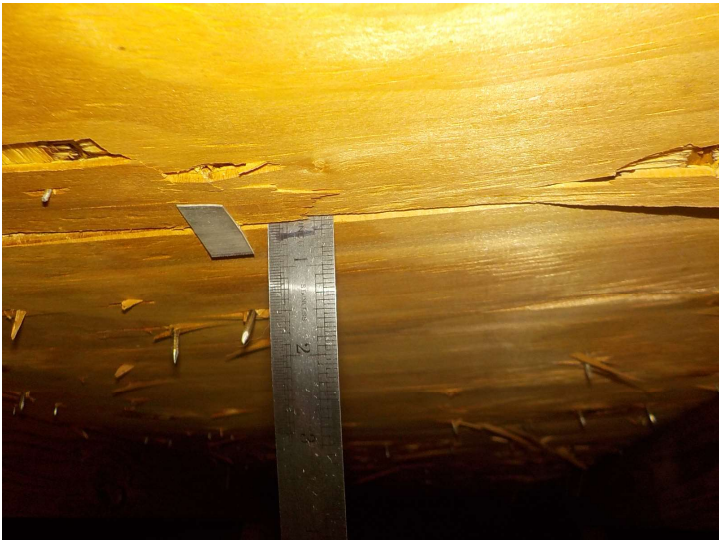
Roof Deck Thickness 1/2 inch plywood

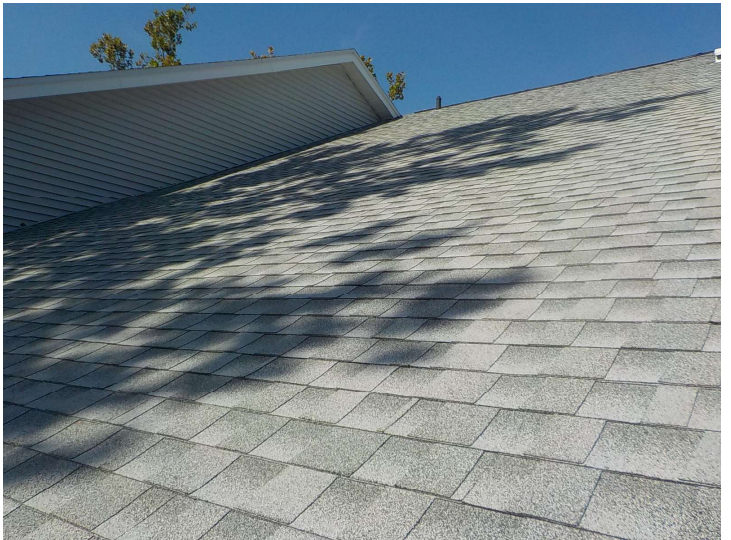
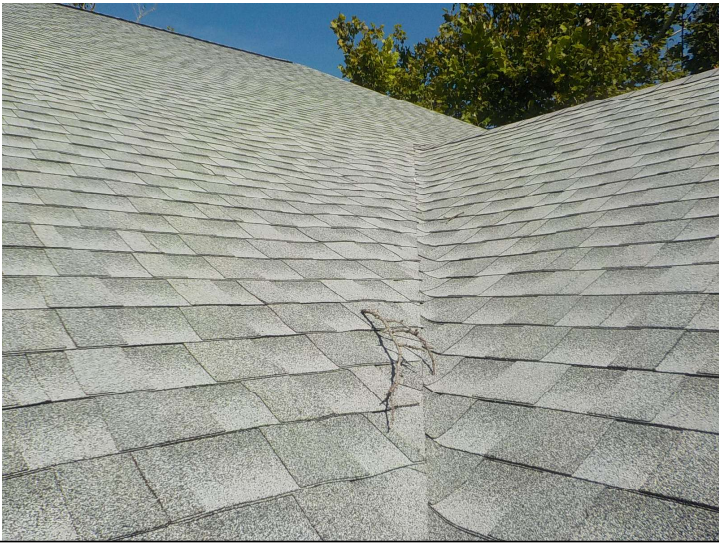
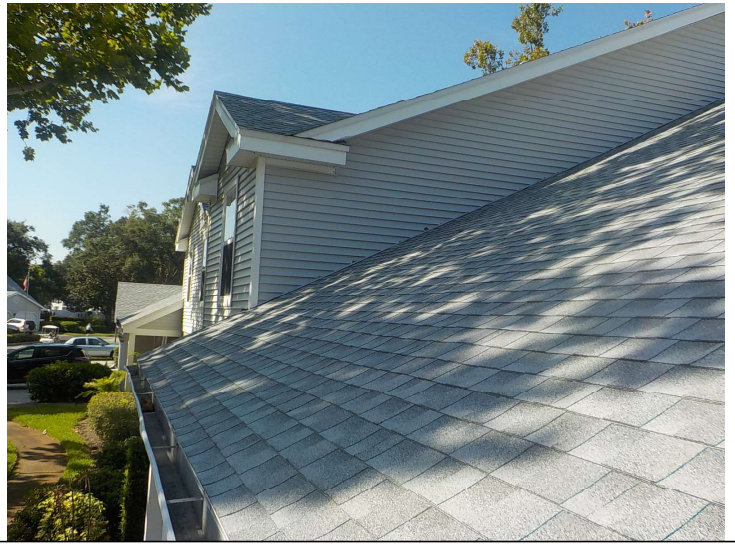
| 2.1 Roof Covering Type: | Permit<br>Application<br>Date | FBC or MDC<br>Product Approval # | Year of Original<br>Installation or<br>Replacement | No Information<br>Provided for<br>Compliance |
|---|---|---|---|---|
| <input checked="" type="checkbox"/> 1. Asphalt/Fiberglass Shingle | 06/03/2022 | | 2022 | <input type="checkbox"/> |

- ☒ A. All roof coverings listed above meet the FBC with a FBC or Miami-Dade Product Approval listing current at time of installation OR have a roofing permit application date on or after 3/1/02 OR the roof is original and built in 2004 or later.

Roof Covering

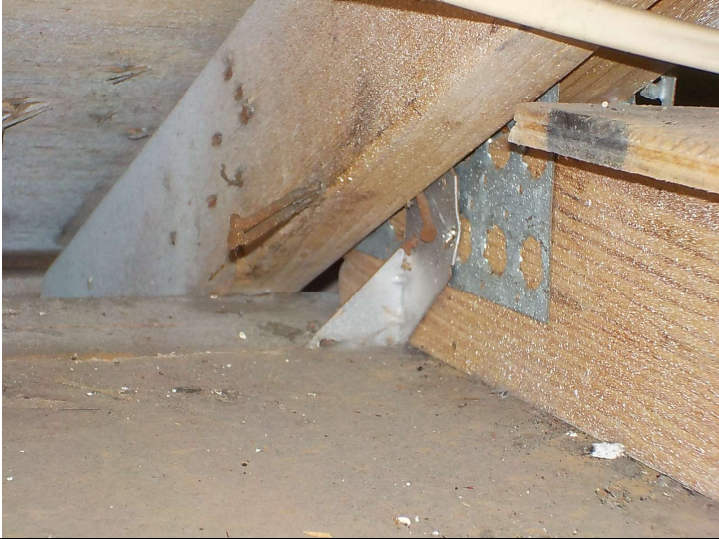
- ☒ Secured to truss/rafter with a minimum of three (3) nails, **and**
- ☒ Attached to the wall top plate of the wall framing, or embedded in the bond beam, with less than a 1/2" gap from the blocking or truss/rafter **and** blocked no more than 1.5" of the truss/rafter, and free of visible severe corrosion.

- ☒ B. Clips
- ☒ Metal connectors that do not wrap over the top of the truss/rafter, **or**
- ☐ Metal connectors with a minimum of 1 strap that wraps over the top of the truss/rafter and does not meet the nail position requirements of C or D, but is secured with a minimum of 3 nails.

Roof To Wall Connection
